Historic Structure Report

Rangers' Club

Yosemite National Park
Yosemite Valley, California

George S. Jaramillo, Historical Architect
History, Architecture, and Landscapes Branch
Resources Management and Science Division

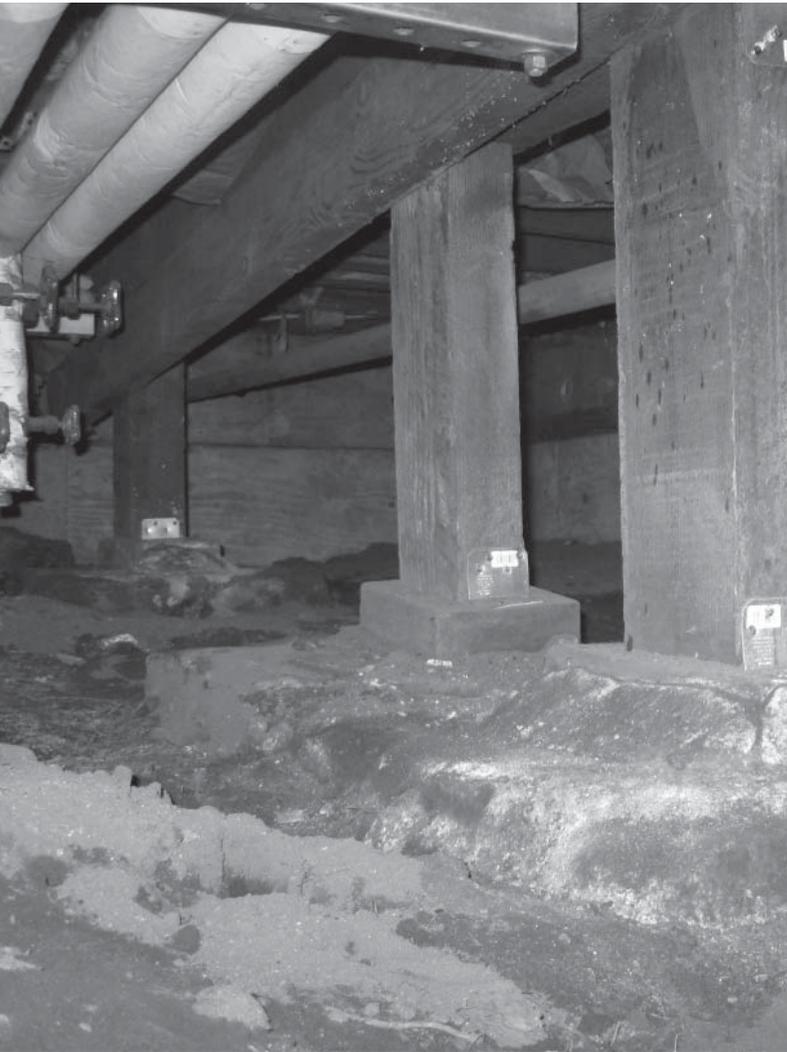
Figure 6.6, clockwise from left: Foundation stone pier footing and post, reinforced foundation, existing stone foundation with efflorescence, note moisture on ground (Summers, 2009)

The soil in the crawl space is damp. Only about 20% of the soil is dry. The moisture in the soil is causing mold to grow on the surface of the soil. Fungi are growing in various locations. This moisture is also causing the granite stones, mortar and concrete to effloresce and causing mold growth on the surface. The sills on top of the concrete foundation show some evidence of moisture damage. The northwestern corner of the west wing has very damp soil and large quantities of mold on the surface of the soil. The eastern bay on the south elevation has water damage at the shear wall. Post, beams and joists in the crawl space are checking, cracking and chipping. The metal screens which cover the vents are not securely in place allowing animals to regularly enter the crawl space evidenced by holes dug in the soil and cracked nut shells in various locations throughout. Another indication that animals have been in the crawl space is that around the vents the insulation batts have been pulled down and has been made into nests on the soil. Batt insulation in other areas is not securely in place and has fallen onto the wet soil. Trash, soda cans and rope have been left in the crawl space.

1. Monitor soil moisture in the crawl space. Improve drainage in crawl space to prevent moisture accumulation.
2. Limit water penetration from both snow melt and roof water to minimize efflorescence.
4. Check for rodents and animals periodically.

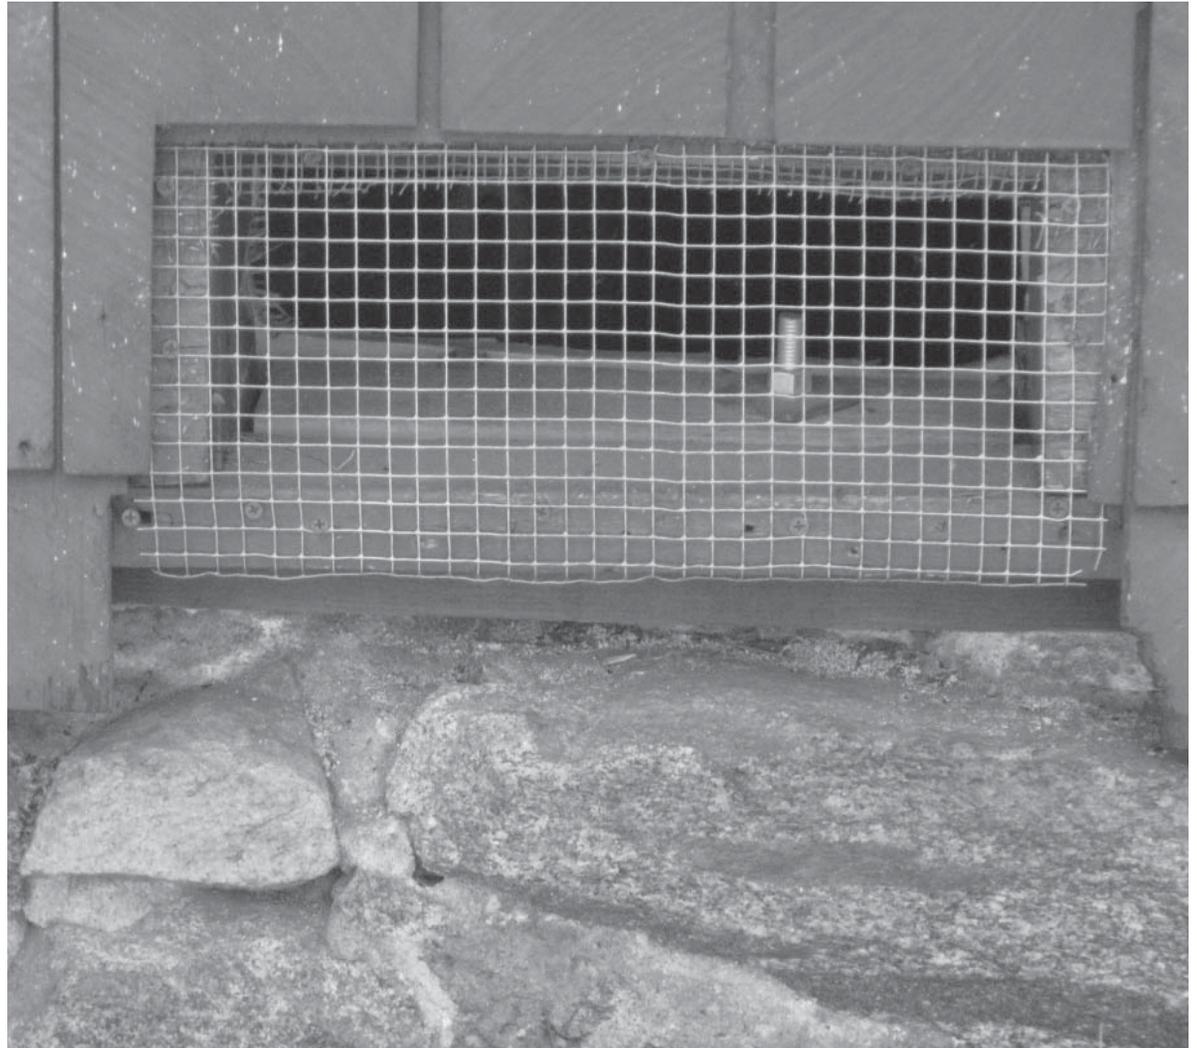
Figure 6.7: Crawlspace vent with added 1/4" metal screen. Although this treatment has kept some pests out it also keeps many of them in. (Jaramillo, 2008)

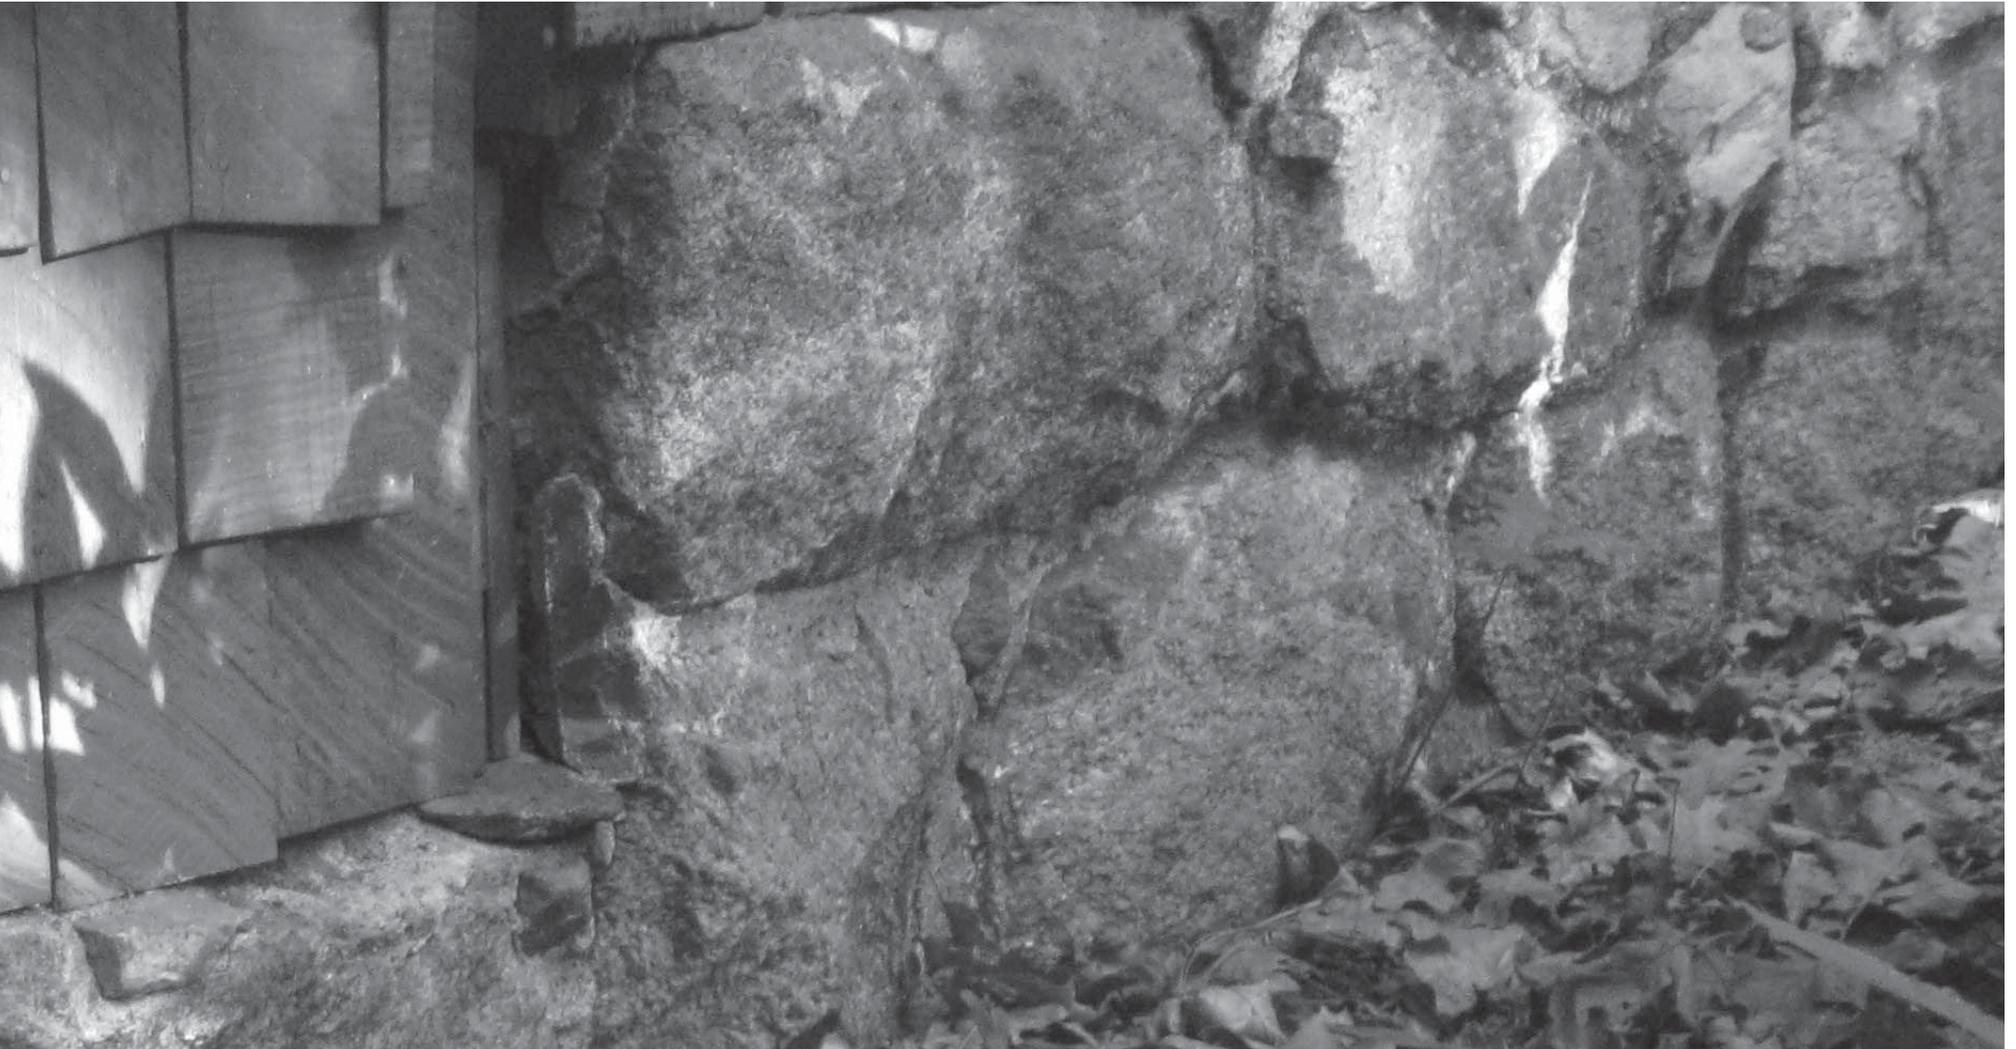
Figure 6.8: Stepped stone foundation with shingled wall. Note the accretion of duff and paint splatter. (Summers, 2008)

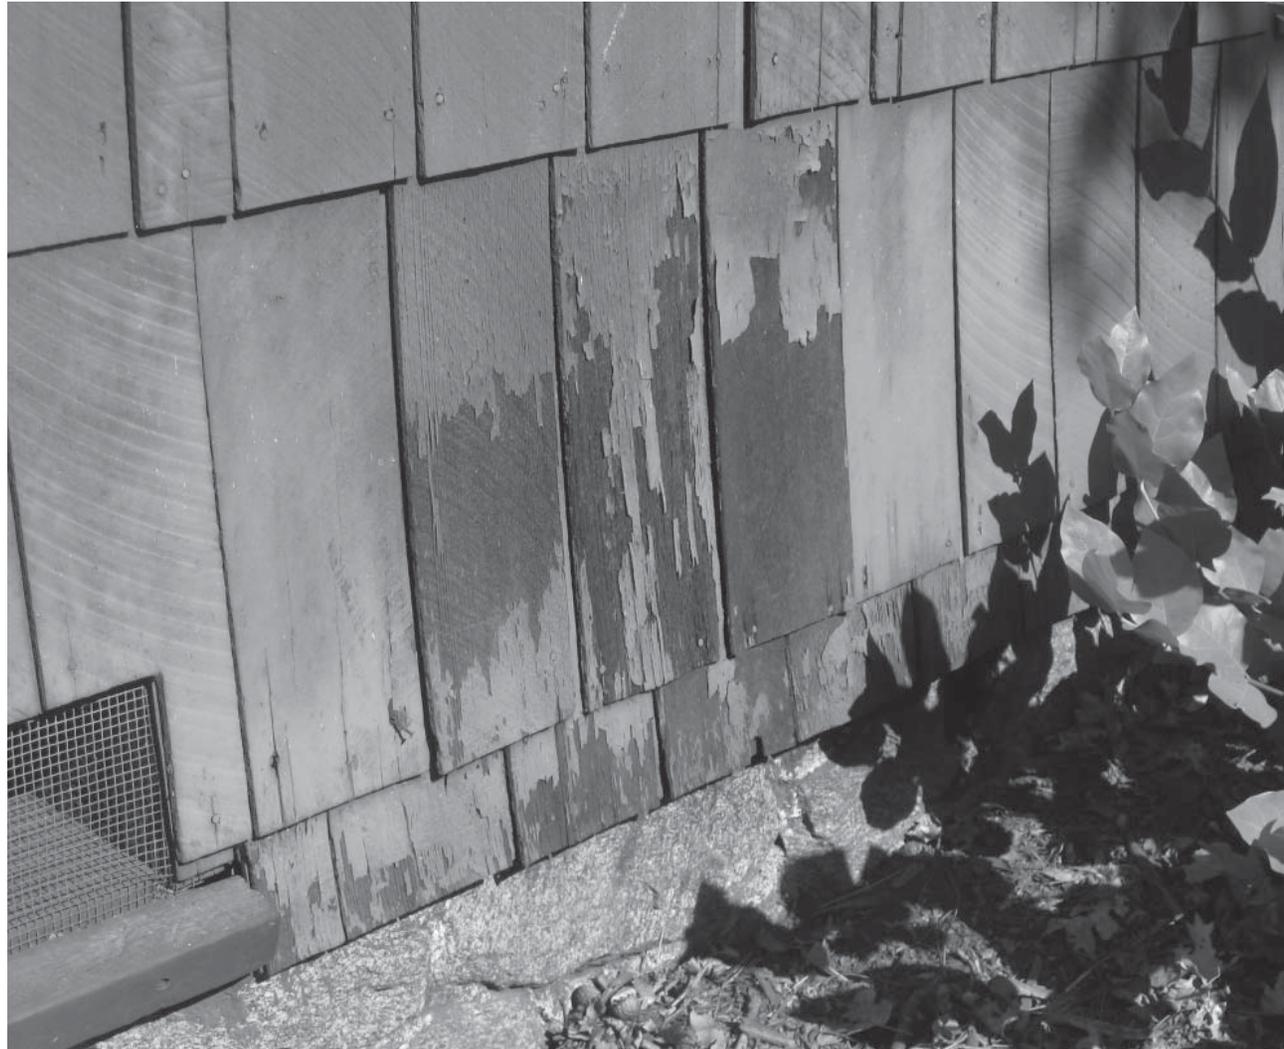
Figure 6.11: Water damaged siding, possibly due to snow accumulation. Note the original brown stain underneath the painted surface. (Summers, 2009)

1. Restore stained finish of shingles and log columns. Match historic wood type and dimensions for all necessary repair and replacement, taking care to conserve all intact historic fabric for reuse. Use semi-transparent oil stain as finish.

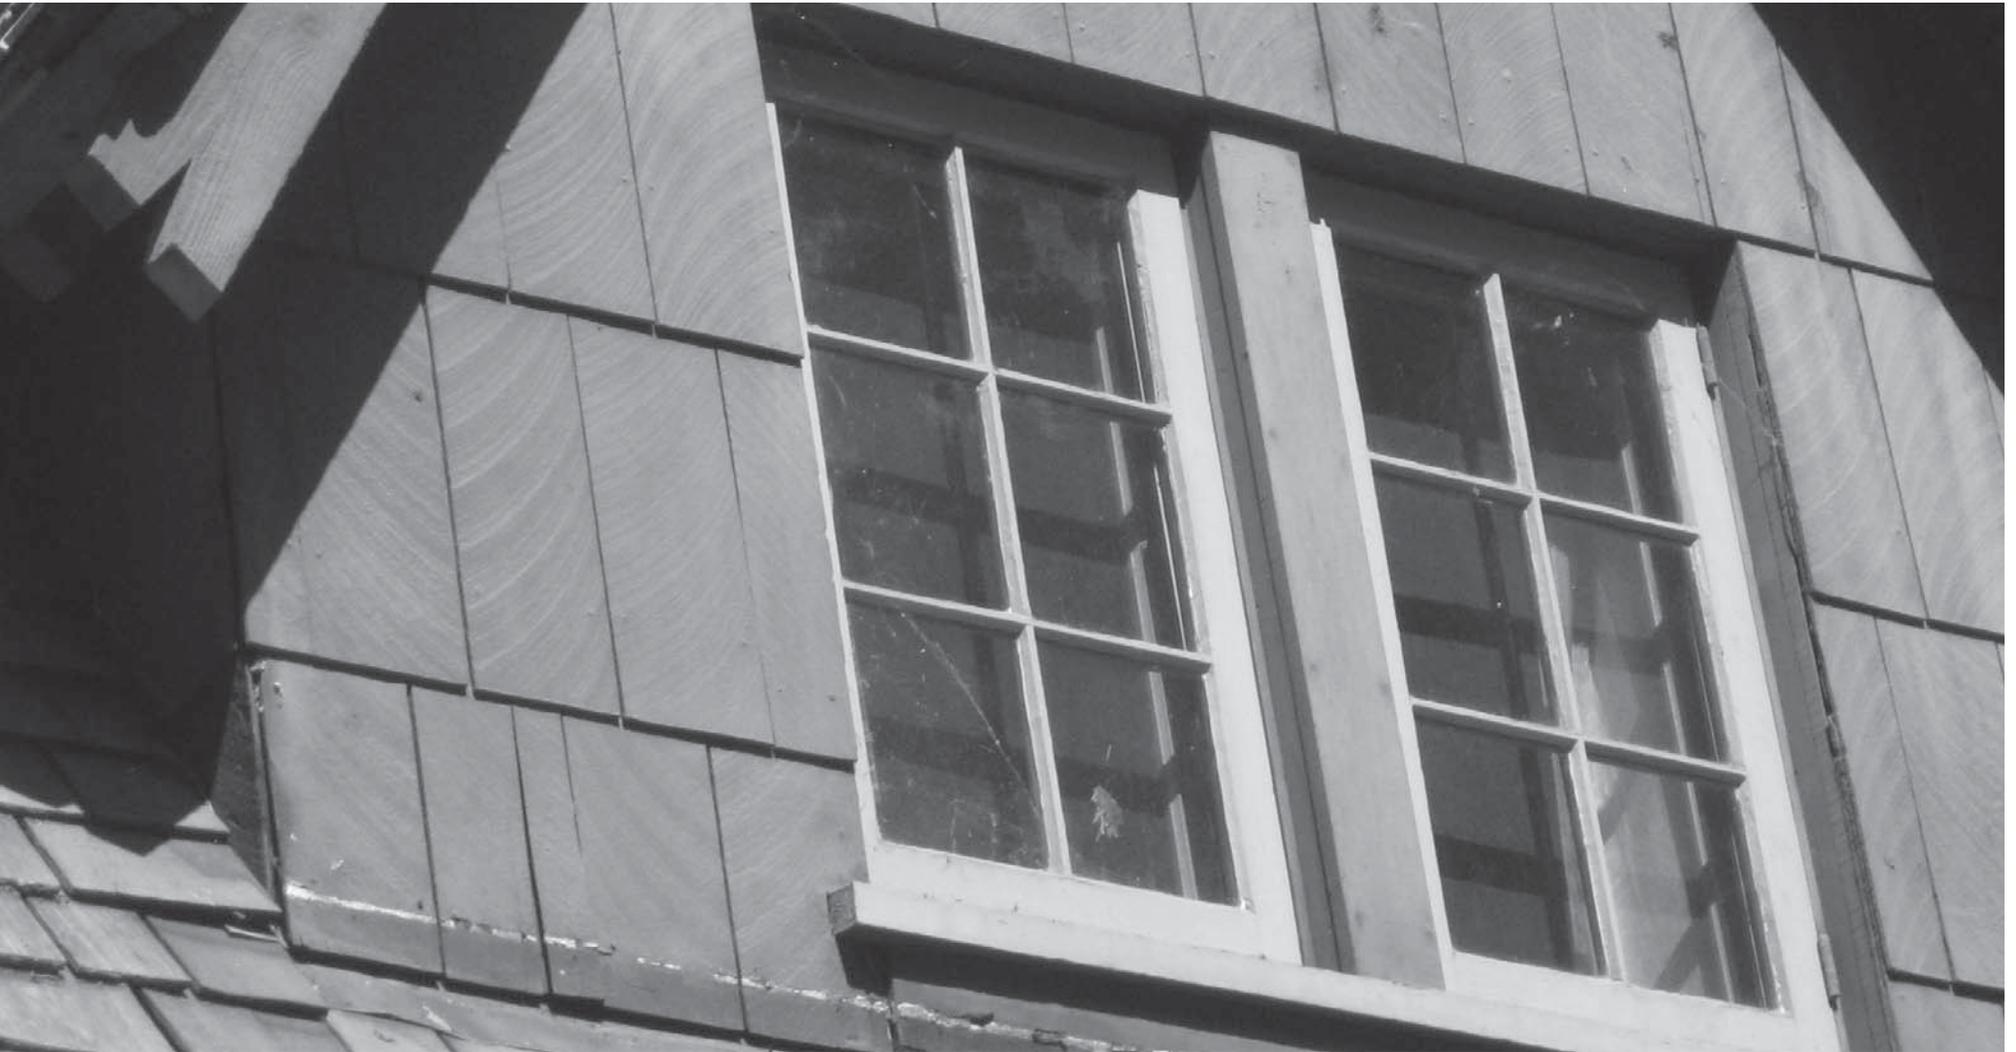
Figure 6.18: Dormer window on west courtyard elevation. Note lower row of shingles with damaged base. (Jaramillo, 2009)

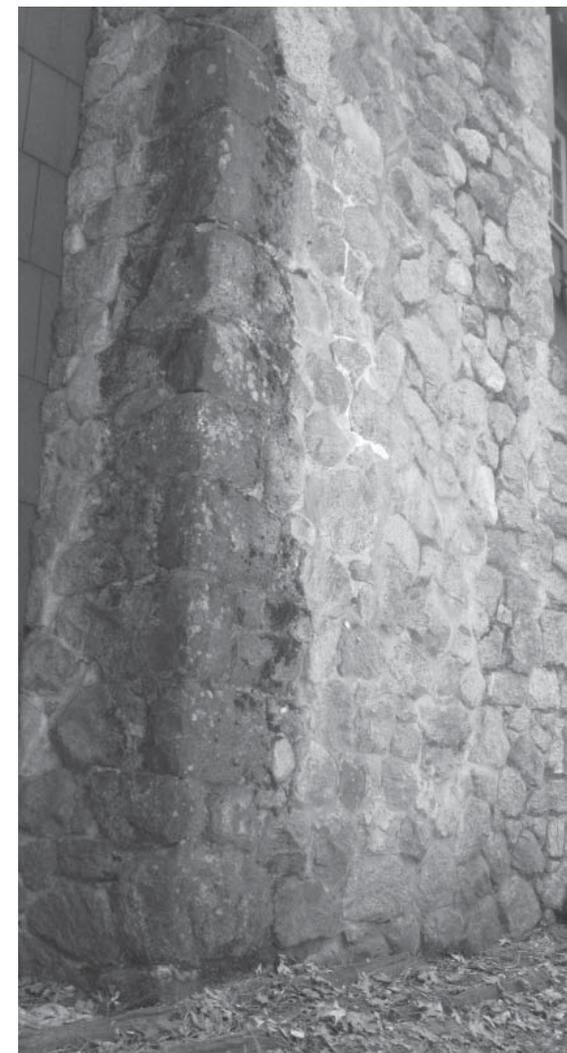
Figure 6.21: Left, interior stub of kitchen chimney supported by wood cribbing, right, organic growth from moisture retention on chimney (Jaramillo, 2009)

1. Consult with structural engineer experienced in treatment of historic buildings to assess stability of the kitchen chimney remnant and provide adequate support. Care must be taken to preserve the historic integrity of this character defining feature.

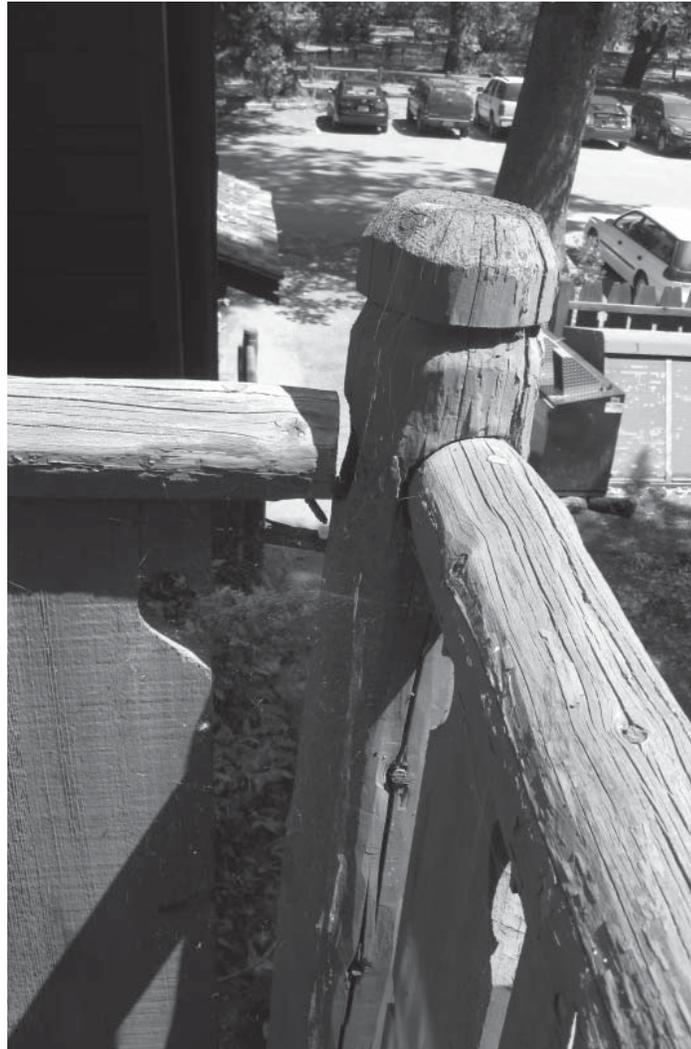
The fire escapes, like the balconies, are in fair to poor condition. The major issue is the instability of the railings which are loose along the length of the balcony and the stair run. Only slight pressure would be needed to cause the failure of the railing. Repairs along the stringer and treads show that the structure is racking. The decking of both balconies is badly weathered with peeling paint and obvious deterioration of the flooring. Bird droppings have accumulated on the fire escapes. The log posts supporting the landing are also loose, and the checking has been aggravated by inappropriate repair using caulk.

Figure 6.28: Above, damaged and racking balcony railing, above right, checked railing post infilled with silicone (detaching), below right, worn and deteriorated deck on north balcony/fire stair (Jaramillo, 2009)

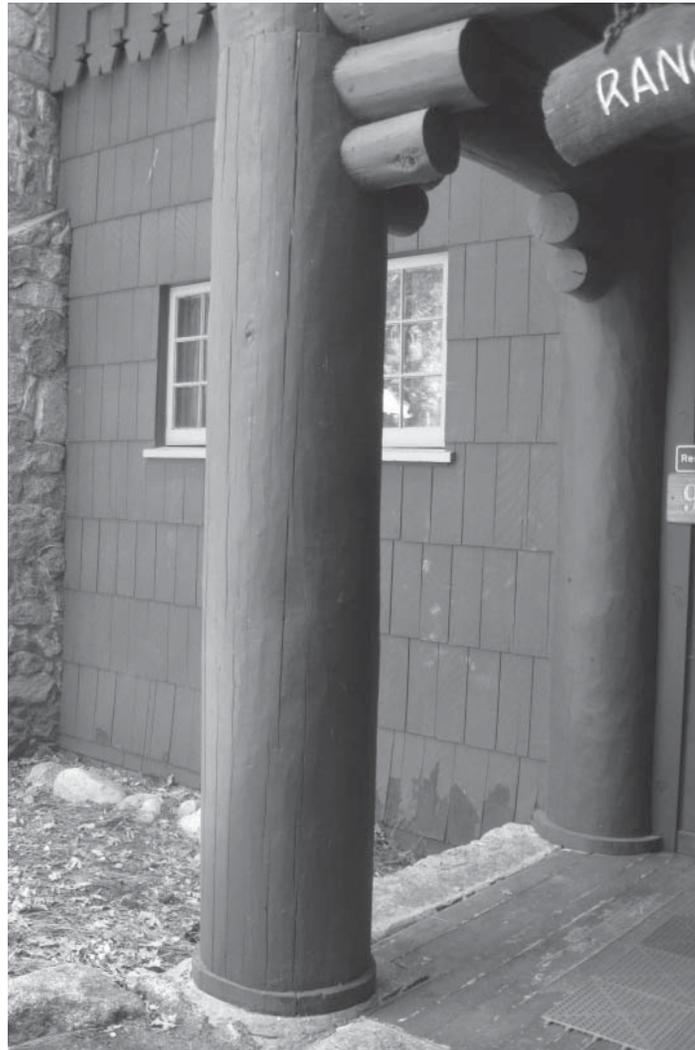
Figure 6.29: Clockwise, upper left, deteriorated deck on south terrace, below left, shed roof of service entry, middle, checked log column, upper right, damaged entry porch floorboards, lower right, damaged shingles on terrace. (Jaramillo, Sommers, Durbin, 2009)

1. Address rain and snow melt drainage problems on south terrace, using visually unobtrusive methods and maintaining historic integrity.

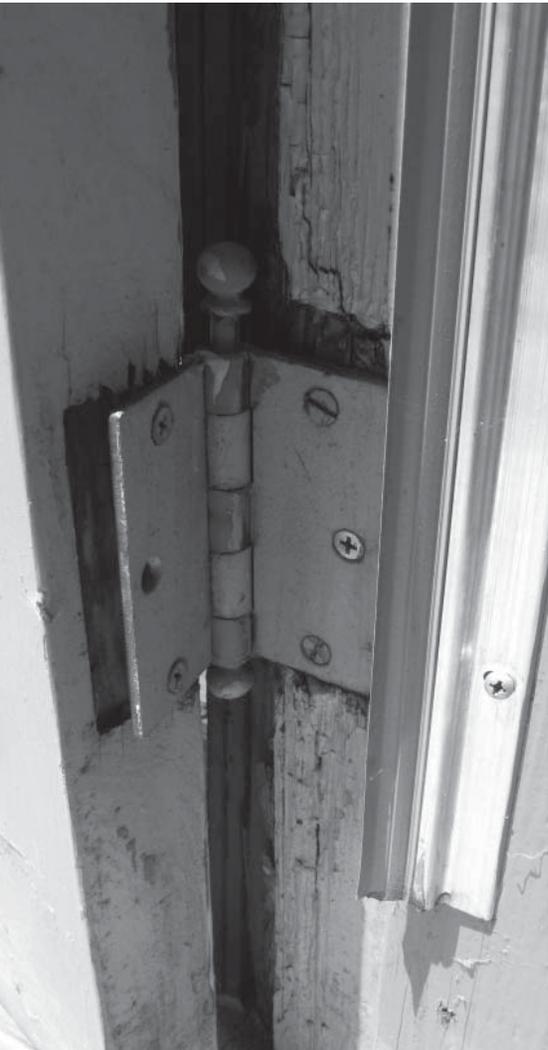
Figure 6.35: Damaged hinged and evidence of moisture on terrace door. Note the added weatherstripping to the door leaf. (Jaramillo, 2009)

1. Prepare plan for restoring terrace doors.

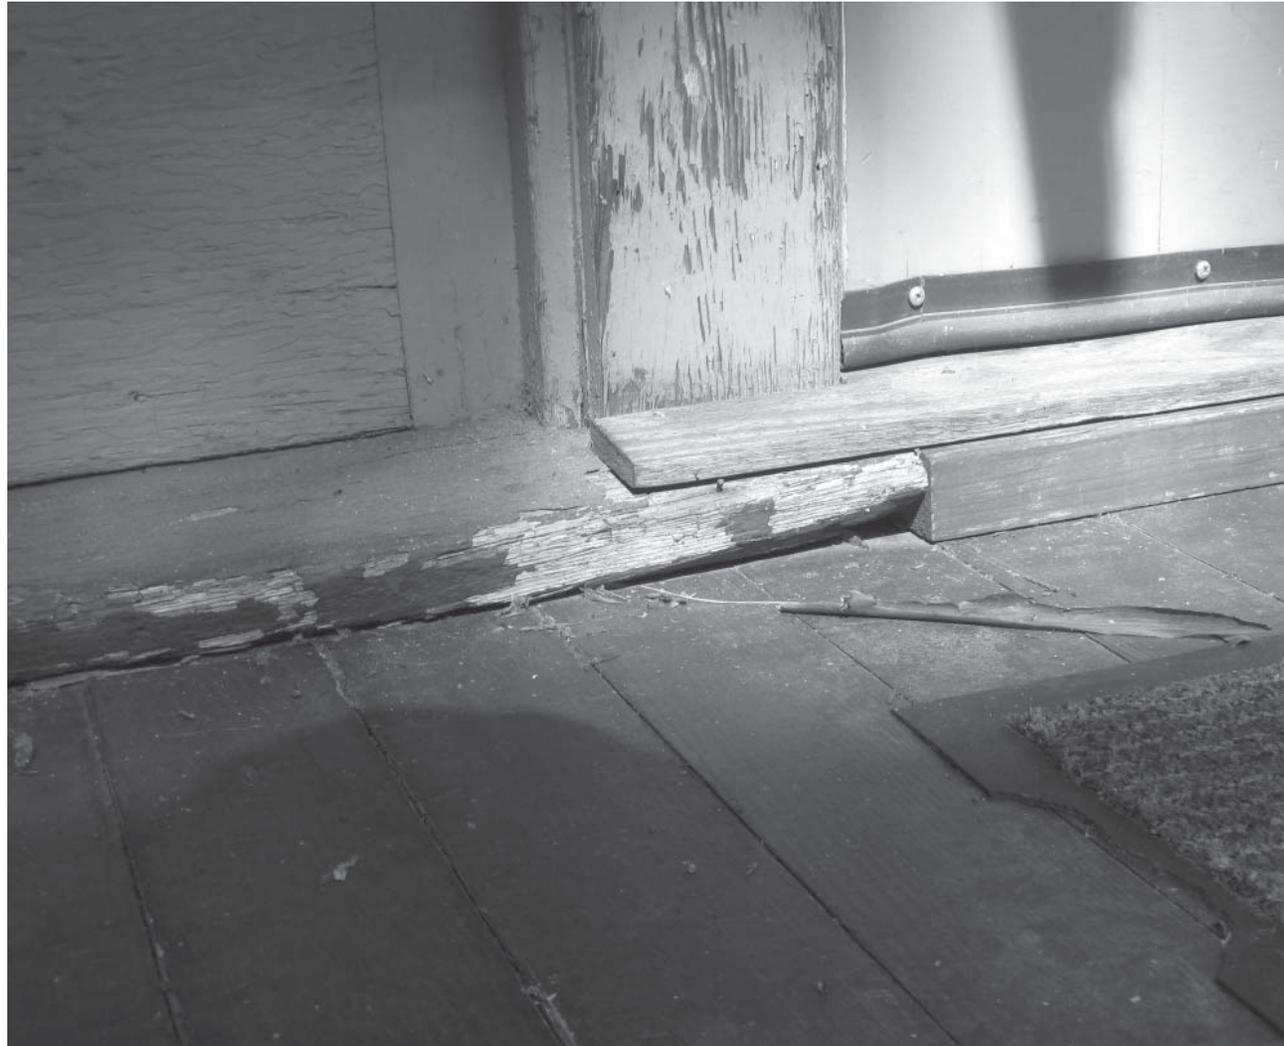
Figure 6.36: Damaged exterior sill on service entry. Note repair to sill and subsequent damage to it and surrounding trim. (Jaramillo, 2009)

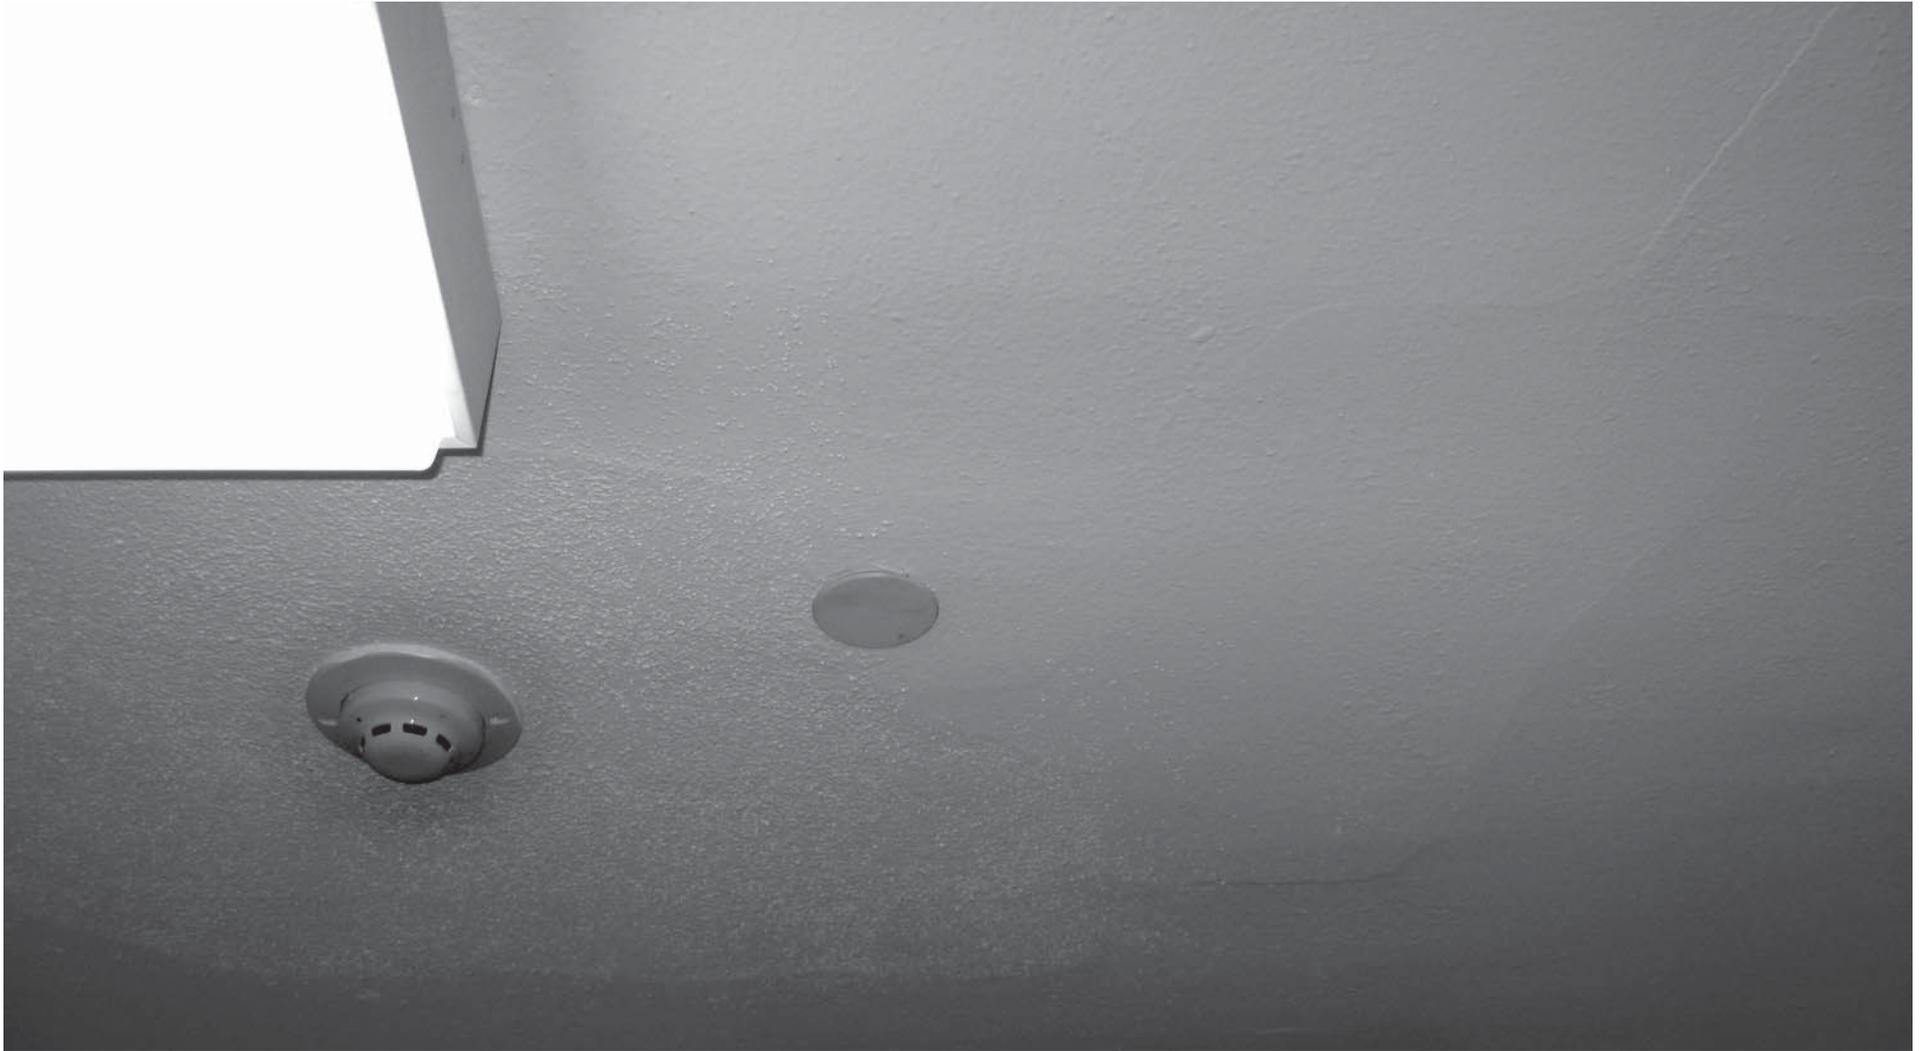
Figure 6.59: Ceiling of Room 6, note cracked and repaired plaster sections (Sommers, 2009)

1. Patch existing cracks in the ceilings.
2. Resurface ceiling to eliminate uneven patching.

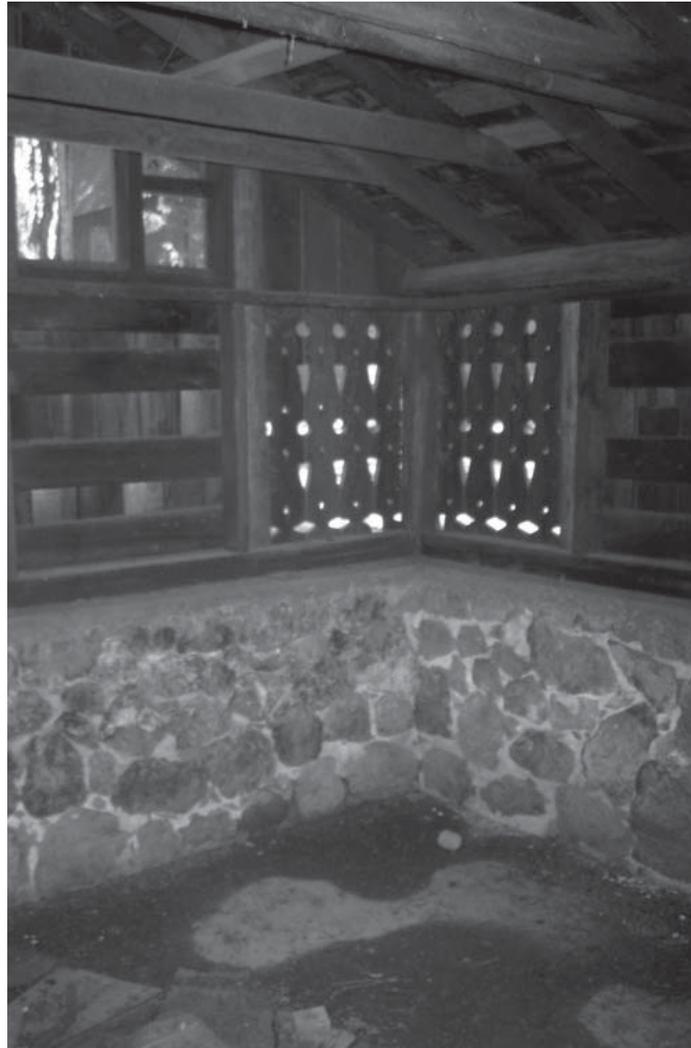
Figure 6.79: Left, Interior of transformer building, right, damaged boards detail. (Jaramillo, 2009)
